Re: Conditional Use Permit, Temporary Wetland Crossing
Eversource ROW Vegetation Establishment Report

PROJECT: G128 AND 307 TRANSMISSION LINE, 2020 STRUCTURE REPLACEMENTS –MADBURY, NH

INSPECTION DATE: OCTOBER 9, 2020

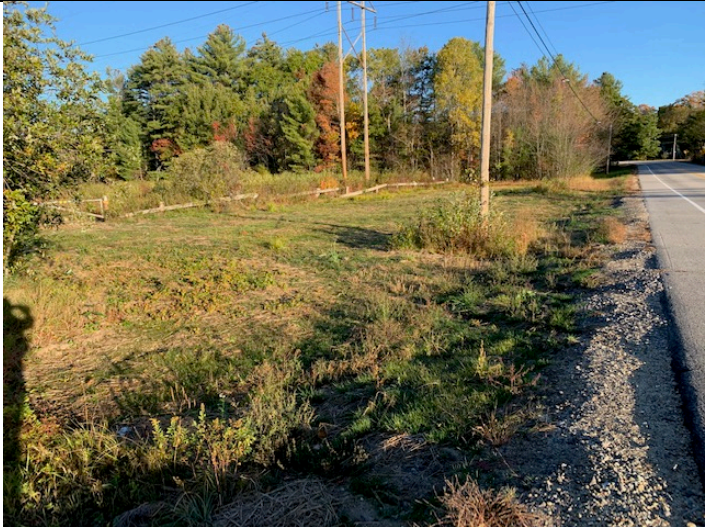
| <p>Photo #1: Access to G128 and 307 ROW.</p> | <p>Location: Madbury Road, Madbury, NH</p> <p>Description: View north at access to the ROW.</p> <p>Area has achieved > 85% vegetative cover.</p> |

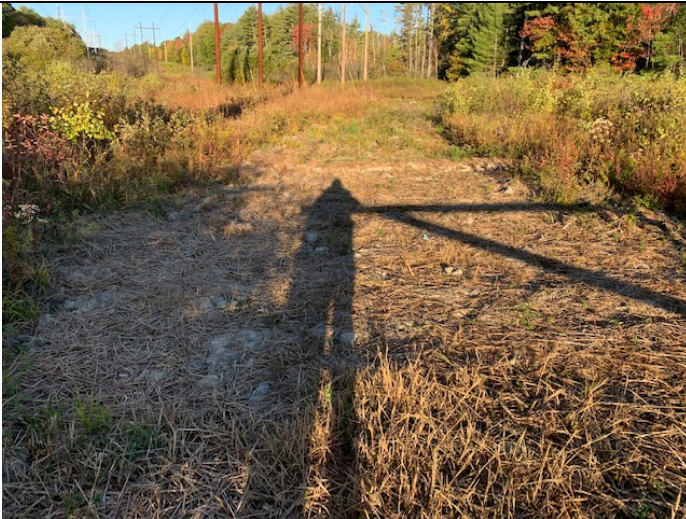
| <p>Photo #2: Gate entrance to the ROW.</p> | <p>Location: Madbury Road, Madbury, NH</p> <p>Description: View west at the access just beyond the gate to the ROW which was ajar at the time of inspection. There is no lock on the gate. Pulled closed.</p> <p>Vegetation has not re-established in this limited area. The ground is hardened and compacted, but stable.</p> |

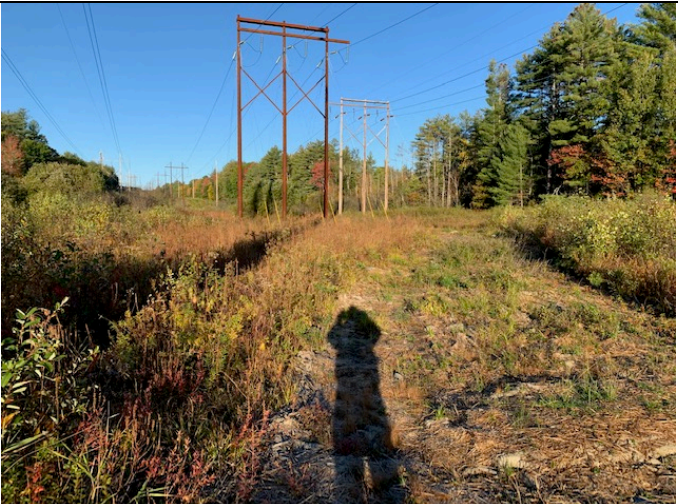
| <p>Photo #3: Access beyond the gated access.</p> | <p>Location: Madbury Road, Madbury, NH</p> <p>Description: View west at the access beyond the gated entrance and the restored construction access that has continued to revegetate.</p> <p>Vegetative cover has achieved 85%.</p> |

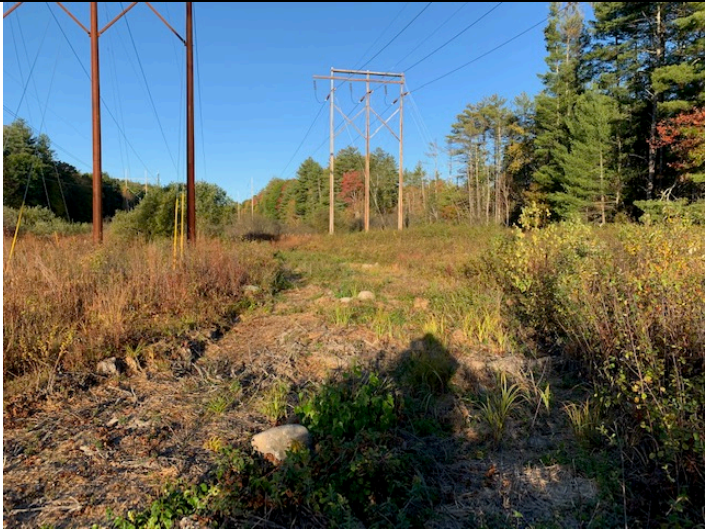
| Photo #4: Access beyond the gated access. | Location: Madbury Road, Madbury, NH |

| | Description: View west at the purple loosestrife that is present in this area and unrelated to the construction. The loosestrife has now died out for the season. |

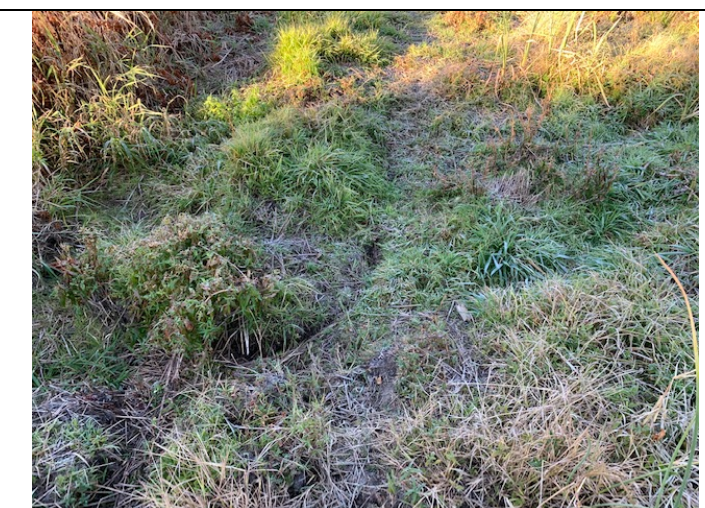
| Photo #6: View of the stream that crosses the access. | Location: G128 Structure 2, Madbury, NH |

| | Description: View west at the stream crossing. The stream channel was revegetated and dry at the time of the inspection. |

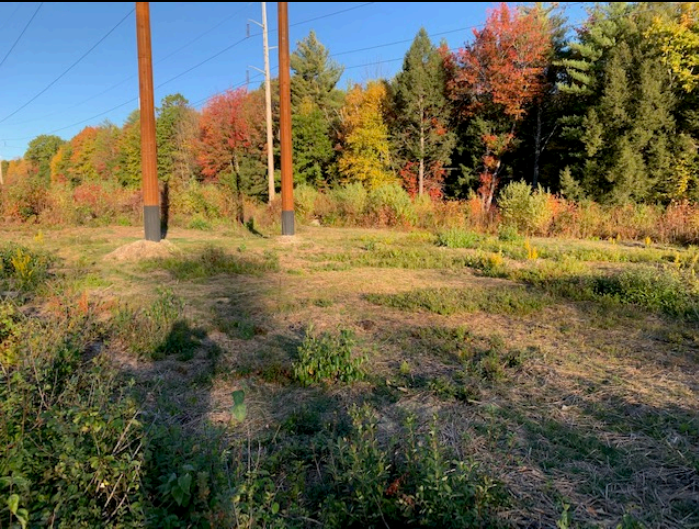
| Photo #7: G128 Structure 4. | Location: G128 Structure 4, Madbury, NH |

| | Description: View northwest at completed G128 Structure 4 replacement. Revegetation of this pad has continued. Vegetative cover has reached 85% cover. |

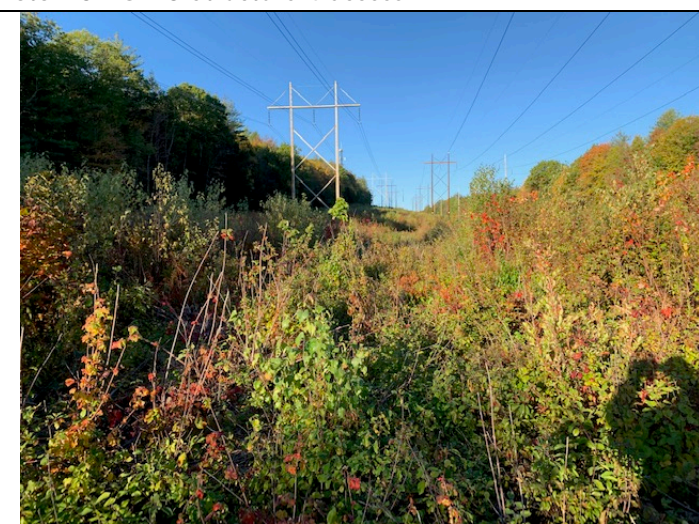
| Photo #8: G128 Structure 4 access. | Location: G128 Structure 4, Madbury, NH |

| | Description: View west at access after timber mat removal. The access road is revegetated. |

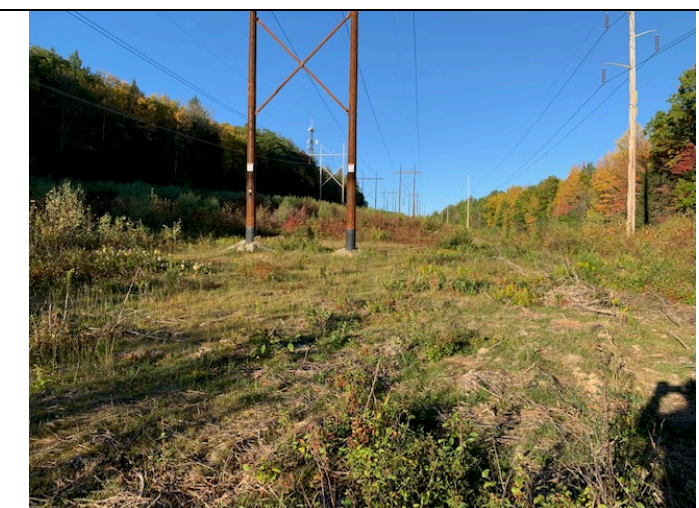
| Photo #9: Work Pad at G128 Structure 5. | Location: G128 Structure 5, Madbury, NH |

| | Description: View west at completed replacement at Structure 5. Vegetative cover has reached 85% cover. |

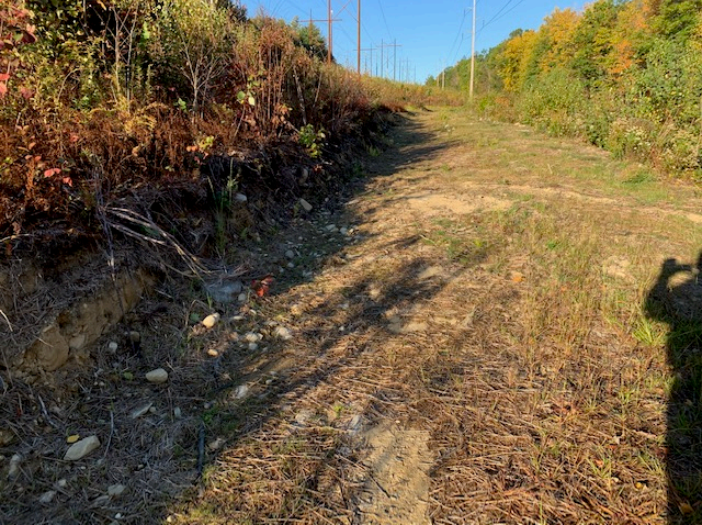
| <p>Photo #10: Access to G128 Structure 6.</p> | <p>Location: Access to G128 Structure 6, Madbury, NH</p> <p>Description: View west at the access road after water bars were installed, eroded areas regraded, and the area seeded and mulched. Vegetation continues to establish along the access road.</p> <p>The majority of the access has achieved 85% vegetative cover. The picture shows one section of the access that is hardened, compacted and dry. It is likely that additional restoration will be required in this area to re-establish vegetation. However, the access is stable with no signs of erosion at this time.</p> |

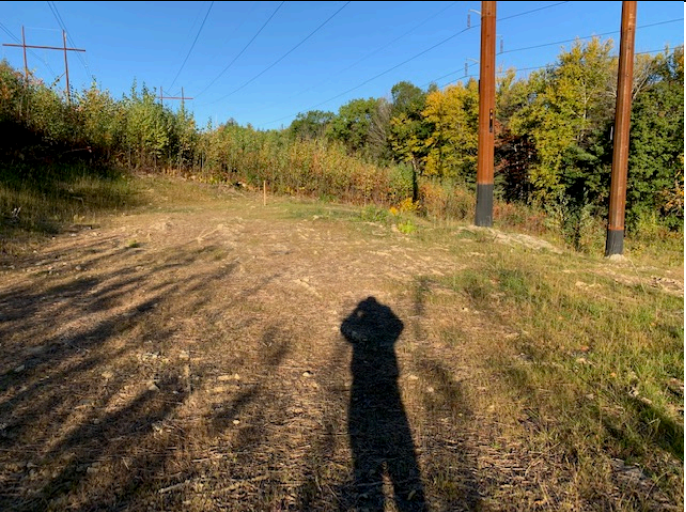
| <p>Photo #11: Work pad at G128 Structure 6.</p> | <p>Location: G128 Structure 6, Madbury, NH</p> <p>Description: View west at the completed replacement at Structure 6. Vegetation is re-establishing, but large areas are still sparsely vegetated as depicted.</p> <p>The area depicted here has achieved 50% vegetative coverage. It is stable with no signs of erosion at this time.</p> |

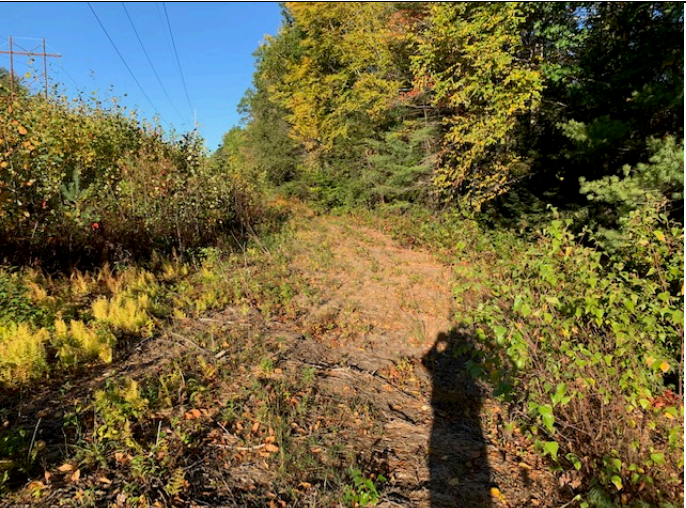
| <p>Photo #12: G128 Structure 6 access.</p> | <p>Location: G128 Structure 6, Madbury, NH</p> <p>Description: View west at the restored area where vegetation is re-establishing along the access beyond the Structure 6 work pad.</p> |

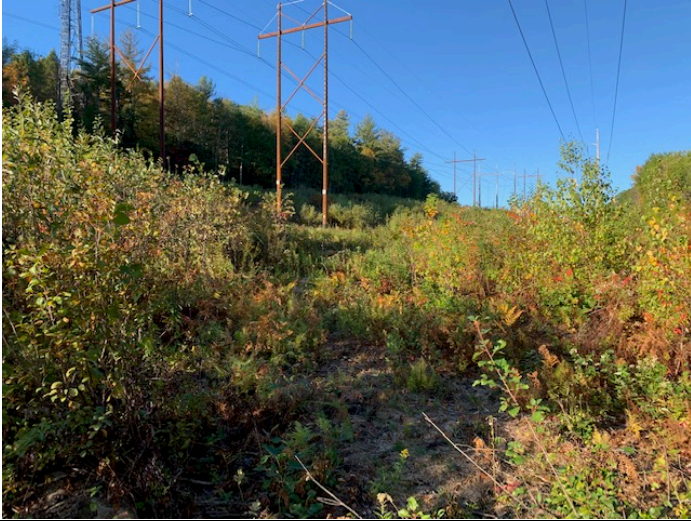
| <p>Photo #13: G128 Structure 7.</p> | <p>Location: G128 Structure 7, Madbury, NH</p> <p>Description: View west at the access to Structure 7 where vegetation has continued to re-establish.</p> |

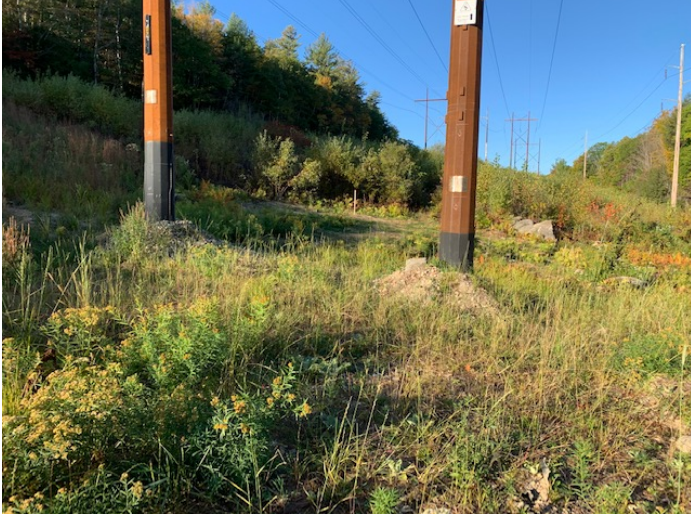
| <p>Photo #14: G128 Structure 7.</p> | <p>Location: G128 Structure 7, Madbury, NH</p> <p>Description: View southwest at work pad at G128 Structure 7. Vegetation has re-established in this work pad.</p> |

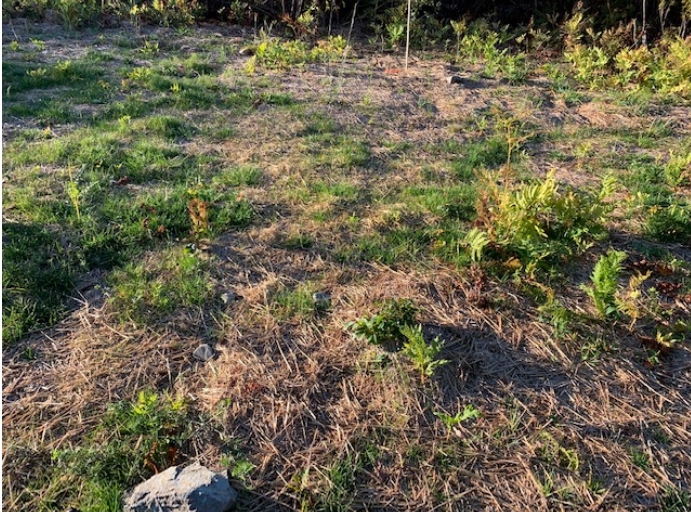
| <p>Photo #15: G128 Structure 7.</p> | <p>Location: G128 Structure 7, Madbury, NH</p> <p>Description: View south at the work pad around Structure 7. Some additional vegetation has re-established along the slope although it is still below 85%.</p> <p>The netting that was put down keeps this area stable.</p> |

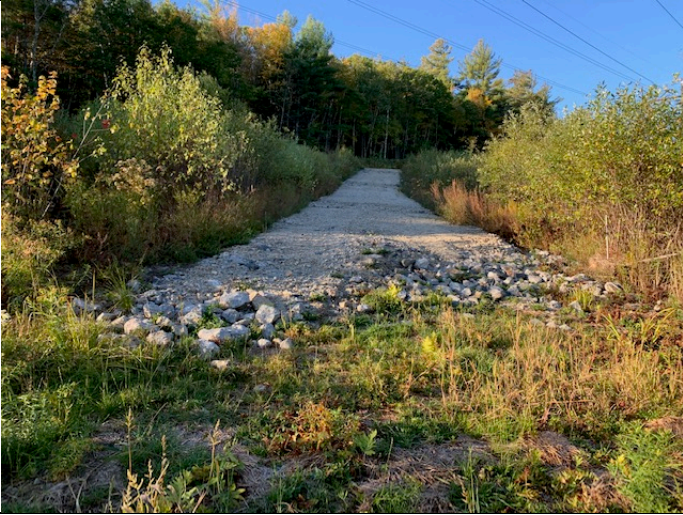
| Photo #16: Access near G128 Structure 7. | Location: G128 Structure 7, Madbury, NH |

| | Description: View west at water diversions constructed along the access near Structure 7. The access is stable at this time. |

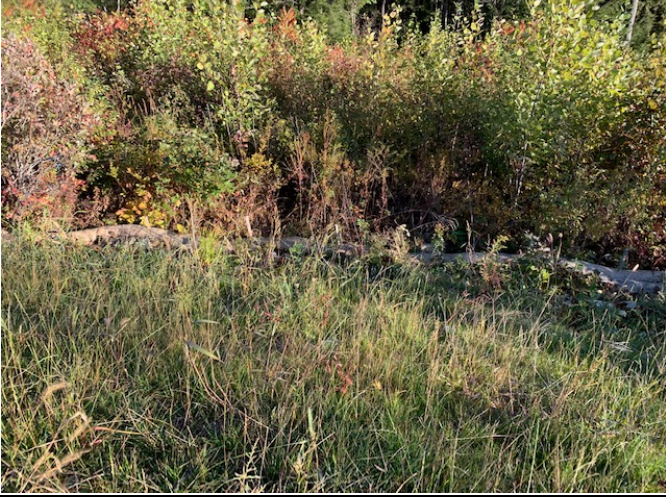
| Photo #17: G128 Structure 8 work pad. | Location: G128 Structure 8, Madbury, NH |

A gravel access road was established to access G128 Structures 8 and 9. There were no temporary wetland impacts associated with these structures. Silt sock was installed as indicated on the approved plan at the base of the slope adjacent to Structure 8 during restoration (Photo 17). See Photos 16 – 20.

| | Description: View east at a restored work pad around G128 Structure 8. Erosion controls were established at the edge of the slope at the wetland boundary. Slope vegetation has reestablished. |

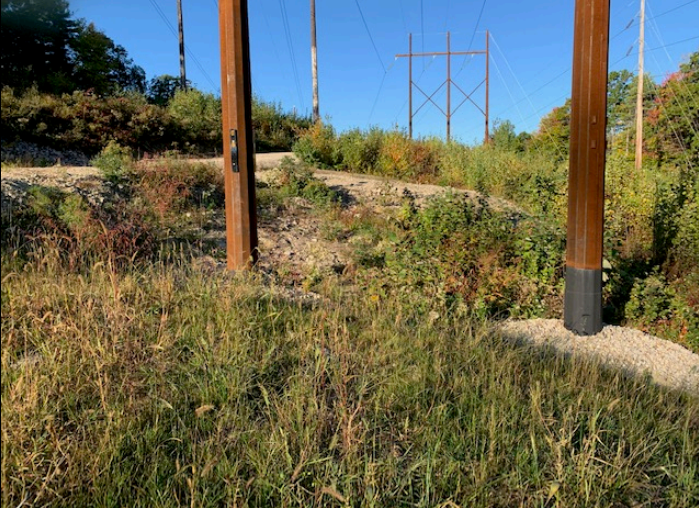
| Photo #18: G128 Structure 8. | Location: G128 Structure 8, Madbury, NH |

| | Description: View northwest at replaced G128 Structure 8 and work pad. Vegetation growth around the structures is well-established. The adjacent area that was restored later does not have any vegetative growth. |

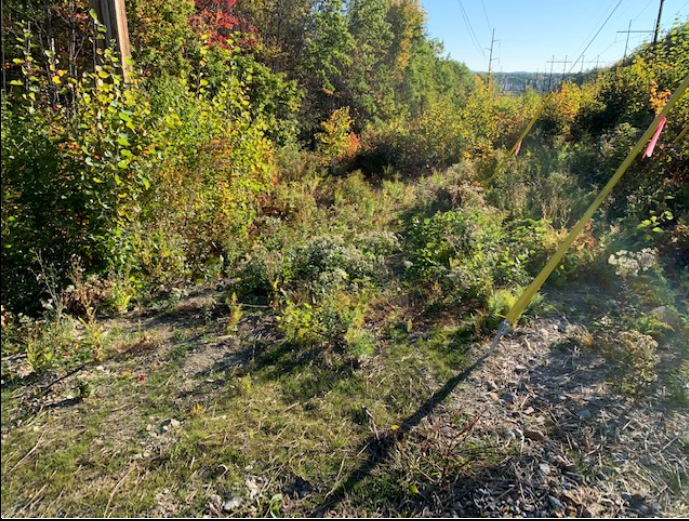
| <p>Photo #19: Access beyond G128 Structure 9.</p> | <p>Location: G128 Structure 9, Madbury, NH</p> <p>Description: View east at area where anchors were installed for G128 Structure 9. Exposed soils have been seeded and mulched around the anchors. Vegetation has established in this area around the anchors.</p> |

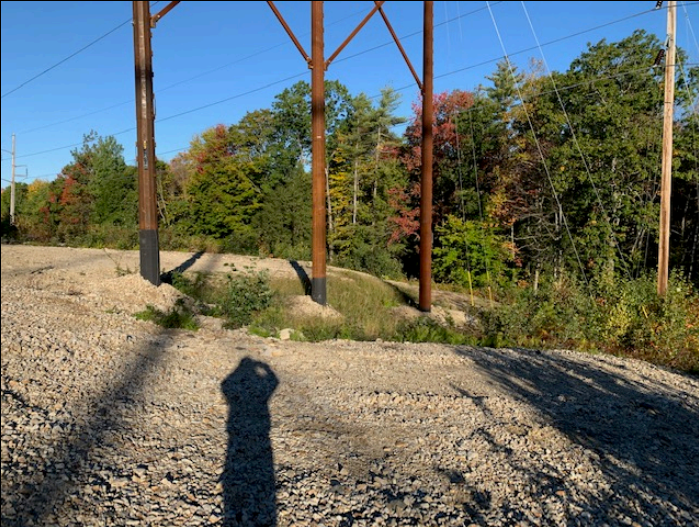
| <p>Photo #20: G128 Structure 9.</p> | <p>Location: G128 Structure 9, Madbury, NH</p> <p>Description: View northwest at work pads around G128 Structure 9. Exposed soils on non-hardened slopes have been seeded and mulched. Vegetation is established around the structure.</p> |
